Changes in EOS 0610i NET/DUO from Firmware revision 1.6

EOS 0610i NET/DUO Firmware v1.5/v1.6 Addendum

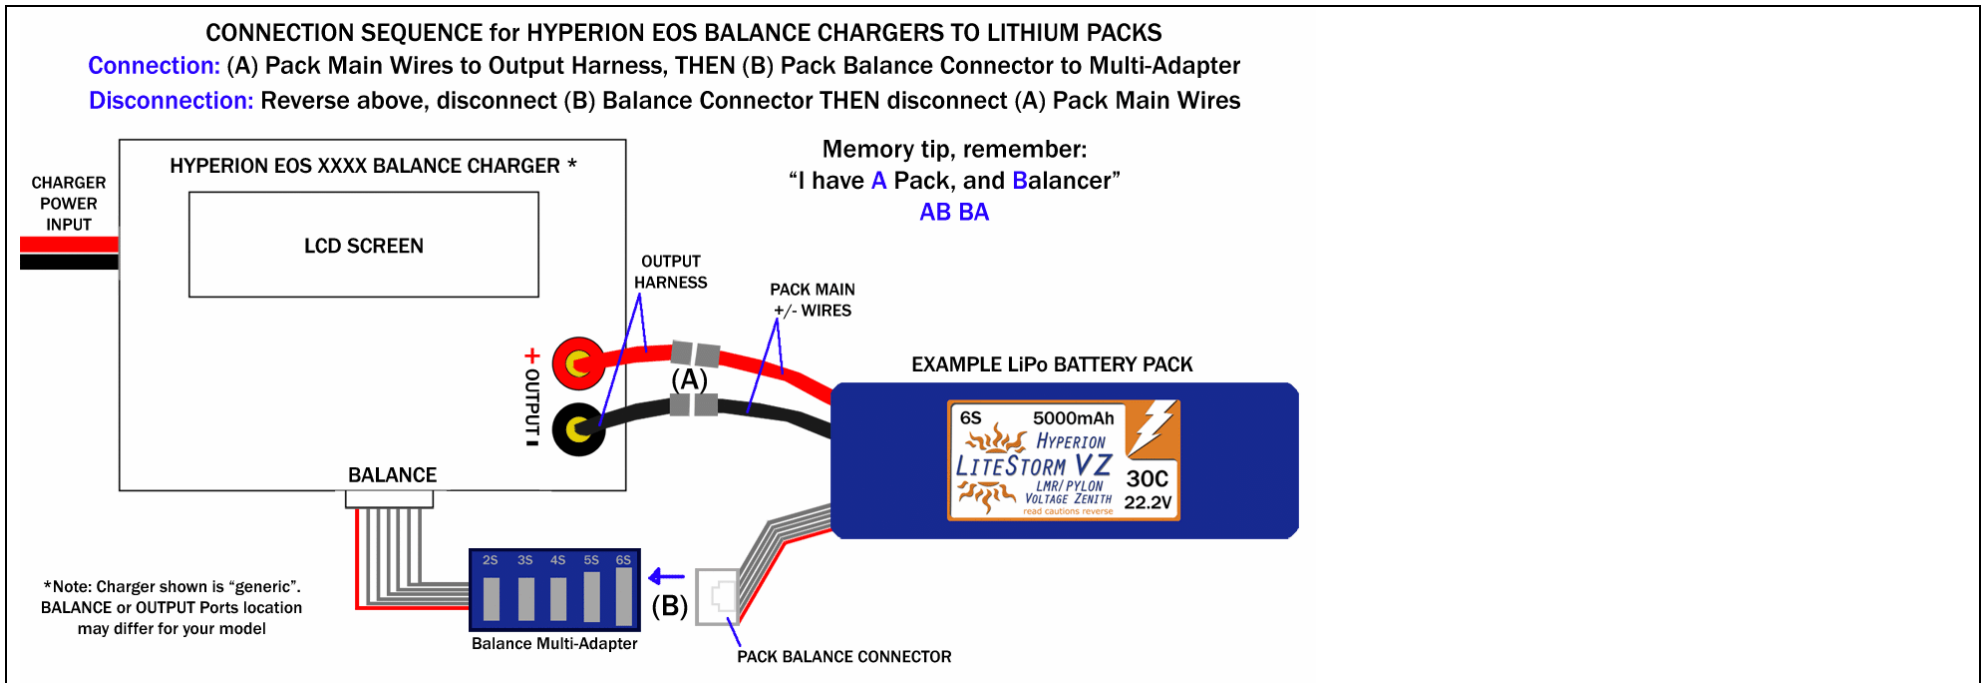
(1) **CHARGER INTERNAL PROTECTION UPGRADE** – The connection sequence of Lithium Packs with Balancer Connector (LiPo, LiFePO4) has an impact on the components inside the charger. The connection sequence shown below reduces surges which occur at pack connection time, greatly reducing possibility of damage to charger components:

In v1.6 NET/DUO firmware, additional protection is provided such that even if correct connection sequence is NOT followed, chances of charger damage are much reduced. Even so, it is always recommended that you follow the connection/disconnection (AB-BA) sequence as shown above.

NOTE: v1.6 firmware also includes a diagnostic routine to identify chargers which have suffered internal damage. If - after updating firmware to v1.6 and attempting to balance charge a Lithium pack - you see an error message “OUTPUT CIRCUIT ERROR” then it means that hardware components have been damaged, and **you MUST return your charger for repair/replacement before further use. NEVER continue to use the charger if you see this message after v1.6 upgrade, nor revert to earlier firmware!**
